**Atlanta Public Safety Training Center**

**April 22, 2021**

Terracon Project No. 49217142

Re: Phase I Environmental Site Assessment

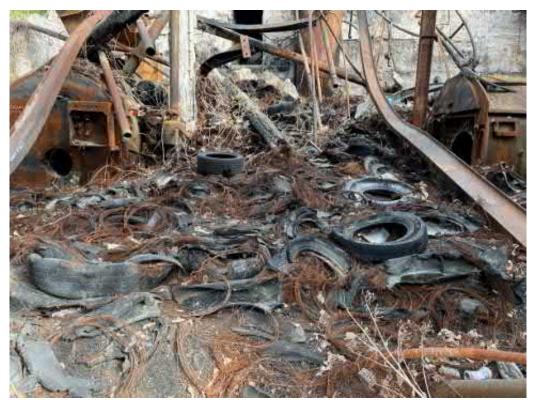
Photo 13: View of the burnt mound of tires, metal, and boilers located in the former boiler room/building on the northern portion of the site.

The remnants of what is left of the former Prison Farm boiler room/building was observed on the northern portion of the site. The structure appeared to be a two-story building, with the roof, and a portion of the western wall missing. Hundreds of piled burnt tires were observed inside the building. According to the site contact Mr. Vence Williams with the City of Atlanta, the city previously poured diesel fuel on the tires in order to burn and reduce the volume of dumped debris located at the facility. The fire was so large that it caused part of the boiler room walls and roof to collapse. The metal scraps from the roof and walls were observed on top of the burnt tire debris. The former boilers were observed to be in tact inside the boiler room/building. Visual observation of the boiler room floor was obstructed due to the large amount of tire debris and the source of fuel over the history of the facility could not be confirmed. It is possible that fuel oil stored in ASTs or USTs were used in conjunction with the boilers. Stained soil and stressed vegetation were observed on the ground surface surrounding the boiler room/building. It is likely that hazardous substances or petroleum products have leached into the soil from the burned tires which constitutes a REC associated with the site. The fueling source for the boilers represents a data gap, which we deem to be significant.

- On-Site REC: There is potential for soil and groundwater impairment beneath the site as a result of the following: stained soil and stressed vegetation associated with the burnt tire activities conducted in the boiler room/building, the bulk storage of hundreds of un-labeled cans in building B1, the stained concrete and former remnants of the concrete fuel dispenser islands and piping observed in building B2, and the stained soil and discarded 55-gallon drums observed in building B3.

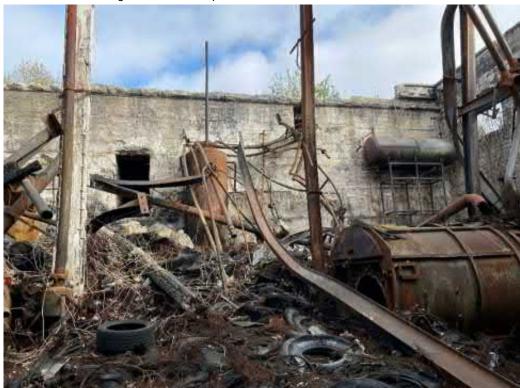
Photo 14: View of the burnt mound of tires, metal, and boilers located in the former boiler room/building located on the northern portion of the site.

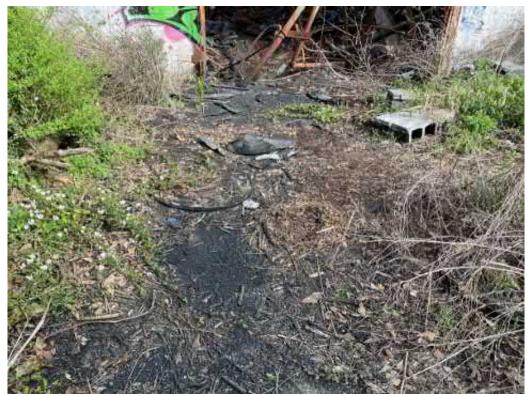
Photo 15: View of the stained soil and stressed vegetation observed on the exterior of the former boiler room/building.

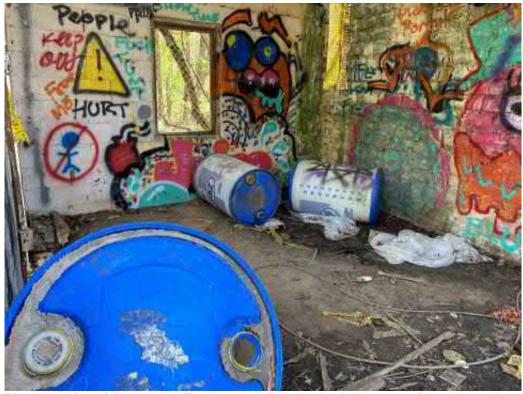
At the time of the Terracon site reconnaissance, the concrete blocks from the bottom of the fuel dispenser islands and additional piping were observed in the interior of building B2. Stained concrete flooring was observed beneath the concrete fuel dispenser blocks. Multiple empty 55-gallon drums of Zep degreaser, trash, and a personal portable gasoline tank were observed in building B2, near the concrete fuel dispenser blocks. Soil sampling beneath the dispenser blocks and additional piping has not been conducted based on information obtained from the GEPD. As such, it is likely that contamination exits underneath building B2 in the area of the fuel dispenser blocks which constitutes a REC associated with the site.

Building B2 was observed to be an approximate 1,300-square foot building structure constructed of brick walls, CMU block walls, and remnants of what is left of an asphalt shingle roof. The former dispenser island used for the former 500-gallon diesel and gasoline USTs was historically located inside building B2. At the time of the Terracon site reconnaissance, the concrete blocks of the fuel dispensers and additional piping were observed in the interior of building B2. Stained concrete flooring was observed beneath the concrete fuel dispenser blocks. Multiple empty 55-gallon drums of Zep degreaser, trash, and a personal portable gasoline tank were observed in building

**Photo 23:** View of the 55-gallon Zep degreaser drums and stained concrete floor observed in building B2.

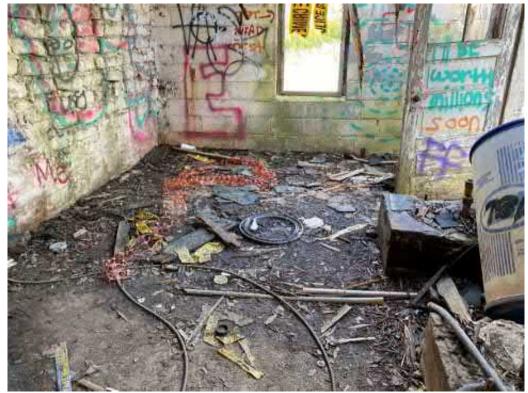
At the time of the Terracon site reconnaissance, the concrete blocks of the fuel dispensers and additional piping were observed in the interior of building B2. The ground surface beneath the concrete fuel dispenser blocks was observed to be concrete, and staining was observed on the floor of the building. Multiple empty 55-gallon drums of Zep degreaser, trash, and a personal portable gasoline tank were observed in building B2, near the concrete fuel dispenser blocks. Soil sampling beneath the dispenser blocks and additional piping has not been conducted based on information obtained from the GEPD. As such, it is likely that contamination exits underneath building B2 in the area of the fuel dispenser blocks which constitutes a REC associated with the site. The remaining interior portion of building B2 could not be observed due to the large amounts of building debris that has gradually collapsed/become dilapidated overtime. Other storage of petroleum products or hazardous substances could be stored under the debris in building B2.

Photo 24: View of the stained concrete floor observed inside building B2.

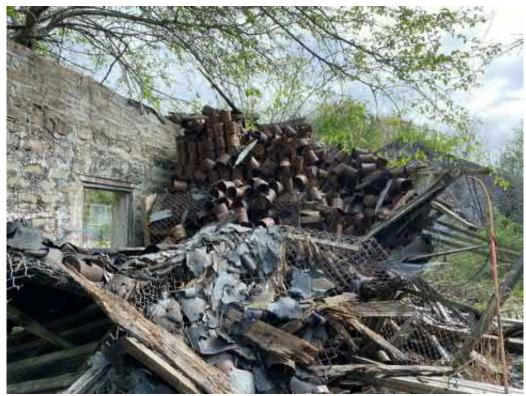
Building B1 was observed to be an approximate 2,800 square-foot building constructed of brick and concrete. The roof of building B1 appeared to have completely collapsed, and remnants of wood, metal, and asphalt shingles were observed covering the ground surface. Hundreds of discarded, not-labeled, rusty metal cans which appeared to be the size of paint cans, and multiple rusty 55-gallon drums were observed in Building B1. The former contents of the cans and drums are unknown, and the ground surface of Building B1 could not be observed due to the cans blocking visual observations. The former use of Building B1 is unknown; however, it was most likely used for storage and/or maintenance of agricultural equipment when the site operated as the Atlanta Prison Farm. Due to the potential for the containers to have contained hazardous

Photo 25: View of the hundreds of discarded metal cans (contents unknown) observed in building B1.

substances and for it to infiltrate the soil and enter groundwater, the hundreds of discarded containers constitute a REC associated with the site.

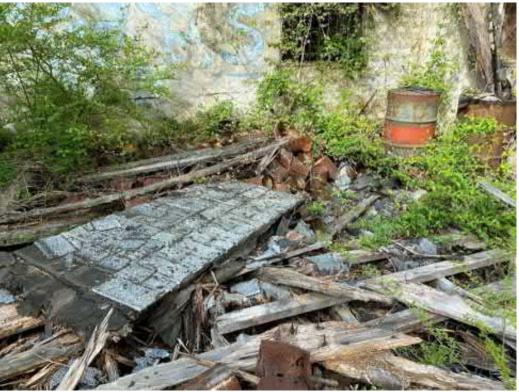
Photo 26: View of the hundreds of discarded metal cans, 55-gallon drums (contents unknown), and dilapidated building materials observed in building B1.

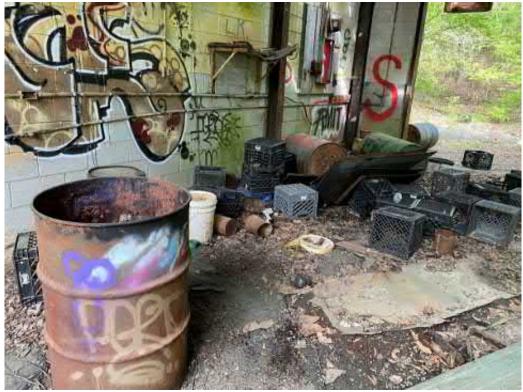
Building B3 was observed to be an approximate 2,500-square foot structure constructed with CMU block walls and a flat metal roof deck. The former use of building B3 is unknown; however, the structure appears in aerial imagery from as early as 1966 when the former Prison Farm operated at the site. The building could have been used to store tractors/ farming equipment, and possible maintenance of tractors could have been conducted inside the building. Building B3 was not constructed on a concrete slab, and the floor was observed to consist of gravel overlying residual soil. Several rusted 55-gallon drums, small storage bins, and trash was observed scattered throughout building B3. Additionally, several large areas of stained soil were observed in building B3. The 55-gallon drums and stained soil observed in Building B3 constitutes a REC associated with the site.

Photo 27: View of the discarded 55-gallon drums (former contents unknown) and stained soil observed in building B3.

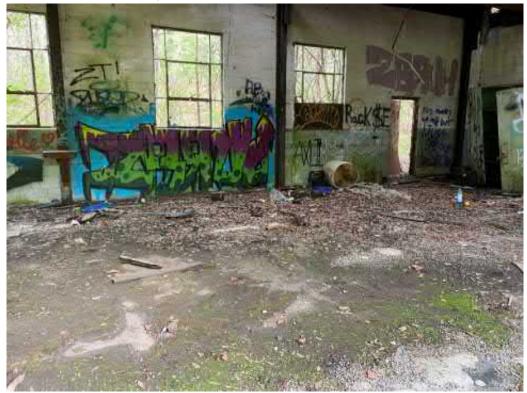
Building B3 was observed to be an approximate 2,500-square foot structure constructed with CMU block walls and a flat metal roof deck. The former use of building B3 is unknown; however, the structure appears in aerial imagery from as early as 1966 when the former Prison Farm operated at the site. The building could have been used to store tractors/ farming equipment, and possible maintenance of tractors could have been conducted inside the building. Building B3 was not constructed on a concrete slab, and the floor was observed to consist of gravel overlying residual soil. Several rusted 55-gallon drums, small storage bins, and trash were observed scattered throughout building B3. Additionally, several large areas of stained soil were observed in building B3. The 55-gallon drums and stained soil observed in Building B3 constitutes a REC associated with the site.

Photo 28: View of the stained soil observed inside building B3.

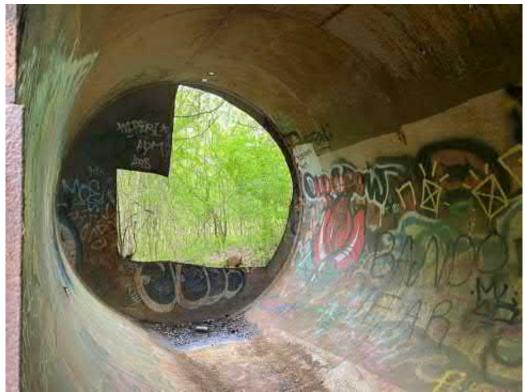
An empty approximate 20,000-gallon AST was observed near the northern/central portion of the site. The former contents and use of the AST are unknown, and no secondary containment was observed on the exterior of the AST. The inside of the AST can be accessed through cutouts on the end and side of the AST, which commonly are cut to prevent further use. No petroleum products were observed inside the AST. No significant staining or other visual evidence indicative of a release, such as stressed vegetation, was identified on the ground surface around the AST at the time of the site reconnaissance. Based on the lack of information regarding the former use and contents of the empty 20,000-gallon AST, this representants a significant data gap to the site.

Photo 29: View of the interior of the empty 20,000-gallon AST observed on-site.

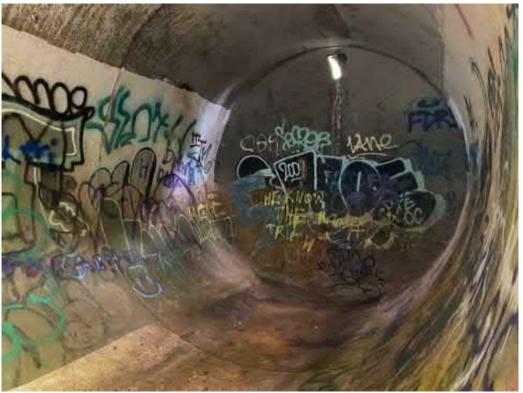
During the site reconnaissance, an empty approximate 20,000-gallon AST was observed near the northern/central portion of the site. The former contents and use of the AST are unknown, and no secondary containment was observed on the exterior of the AST. The inside of the AST can be accessed through cutouts on the end and side of the AST, which commonly are cut to prevent further use. No petroleum products were observed inside the AST. No significant staining or other visual evidence indicative of a release, such as stressed vegetation, was identified on the ground surface around the AST at the time of the site reconnaissance. Based on the lack of information regarding the former use and contents of the empty 20,000-gallon AST, this representants a significant data gap to the site.

**Photo 30:** View of the interior of the empty 20,000-gallon AST observed on-site.

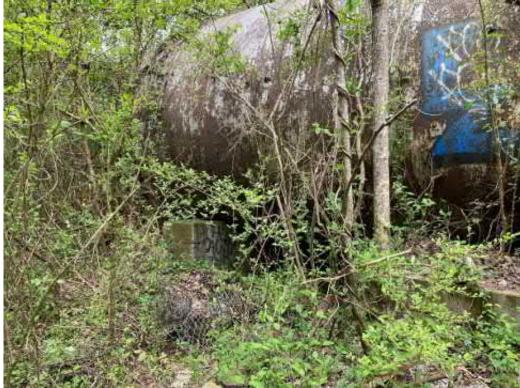
Photo 31: View of the exterior of the empty 20,000-gallon AST observed on-site.

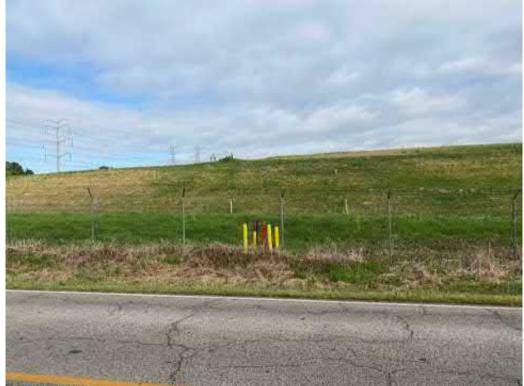
The Key Road Landfill located adjacent and to the north of the site is listed in the environmental regulatory database report as a SEMS-Archive and GA Non-Hazardous Site Inventory (HSI) and operated as a municipal solid waste landfill from approximately 1969 to 2001. A 2018 post closure checklist report obtained from GEPD, indicated the landfill was capped, covered with grass, clay, and soil, and slopes were terraced to slow soil erosion. The landfill is also monitored by a gas collection system and flare, a groundwater monitoring system, and methane monitoring probes. Groundwater at the Key Road Landfill has historically been encountered at approximately 10 to 55 feet, and measured to flow east/northeast towards Intrenchment Creek. The monitoring well closets to the site has exhibited concentrations for four metals (barium, cobalt, mercury, and zinc) significantly above background levels. Based on the proximity to the landfill and duration of operation (at least 30 years), it is likely that hazardous substances from the landfill could have leached into the soil, and impacted groundwater may exist beneath the site. As such, the Key Road landfill constitutes a REC associated with the site.

Photo 36: View of the groundwater monitoring well observed on the southern boundary of the Key Road Landfill located along Key Road SE (north of the site).
